Gunners Brook: Phase I Flood Mitigation Study (Final)

The City of Barre, VT

**DuBois & King, Inc.
28 North Main St.
Randolph, VT 05060**

November 28, 2015

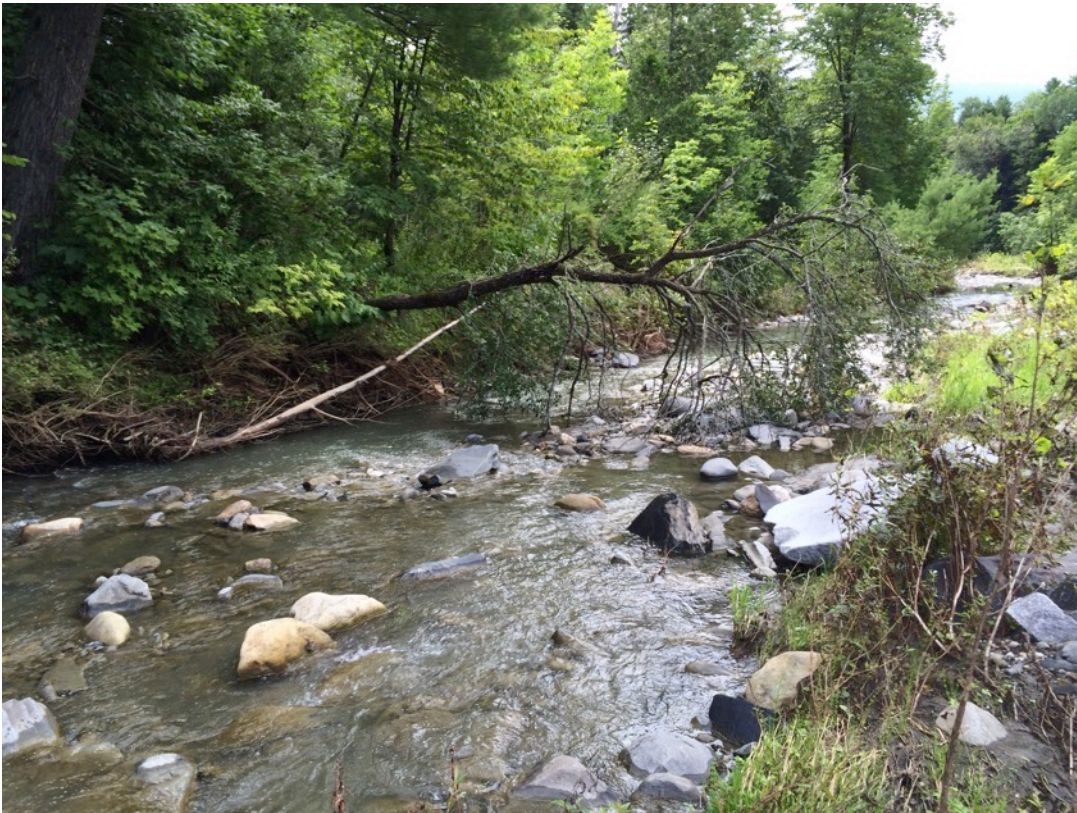
View of Gunners Brook at LePage Gravel Pit area

2.1 Large Woody Debris Rack, located in the vicinity of the LePage Gravel Pit. The purpose of this engineered trash rack is to arrest further downstream movement of large woody debris and to serve as an area where the debris can collect during a flood and then be subsequently removed by the City. A site plan and schematic of this trash rack is appended to this report illustrating its locations and style. Key components of this trash rack include:

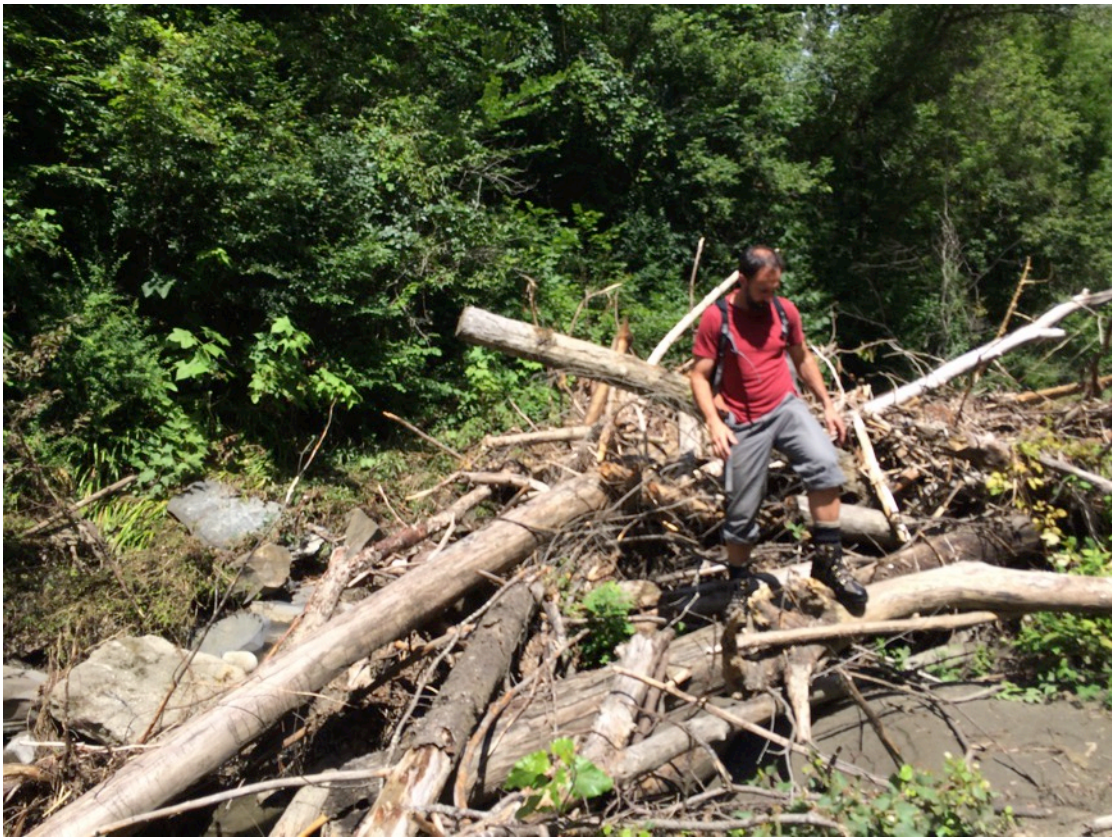
Large woody debris pile in Gunners Brook, upstream of Brook St.

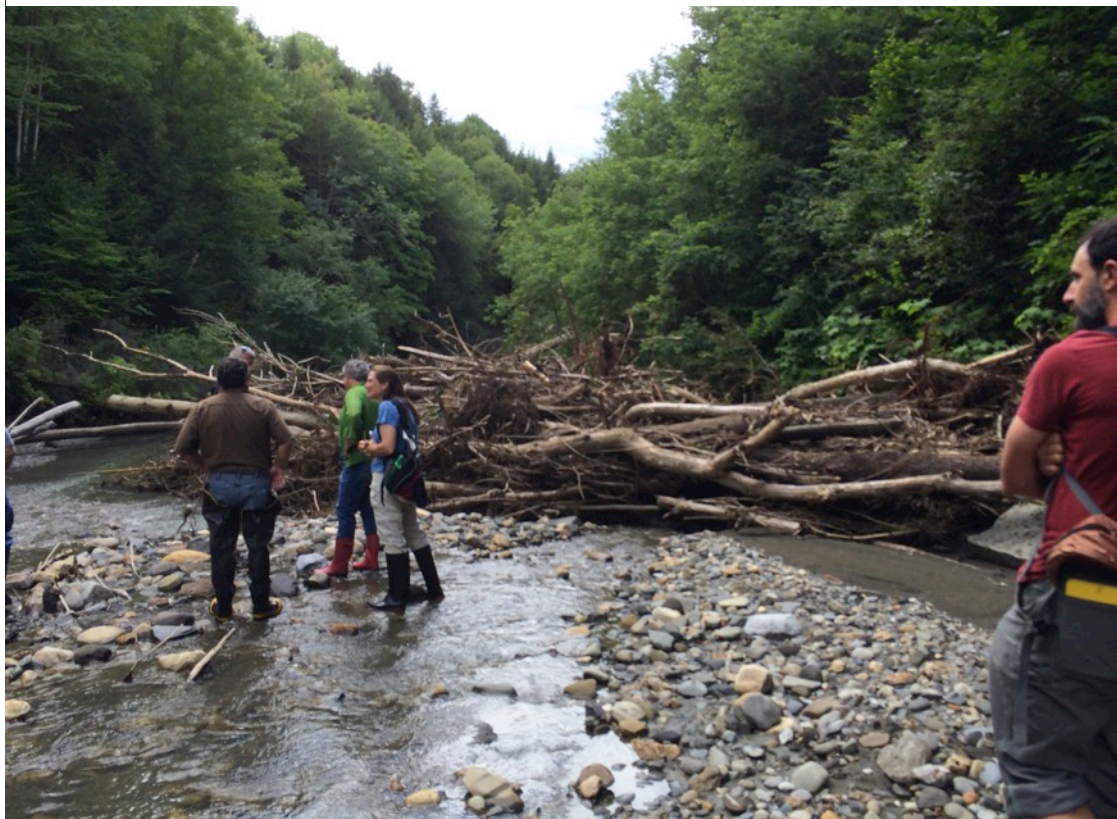
Large woody debris pile in Gunners Brook, upstream of Brook St.

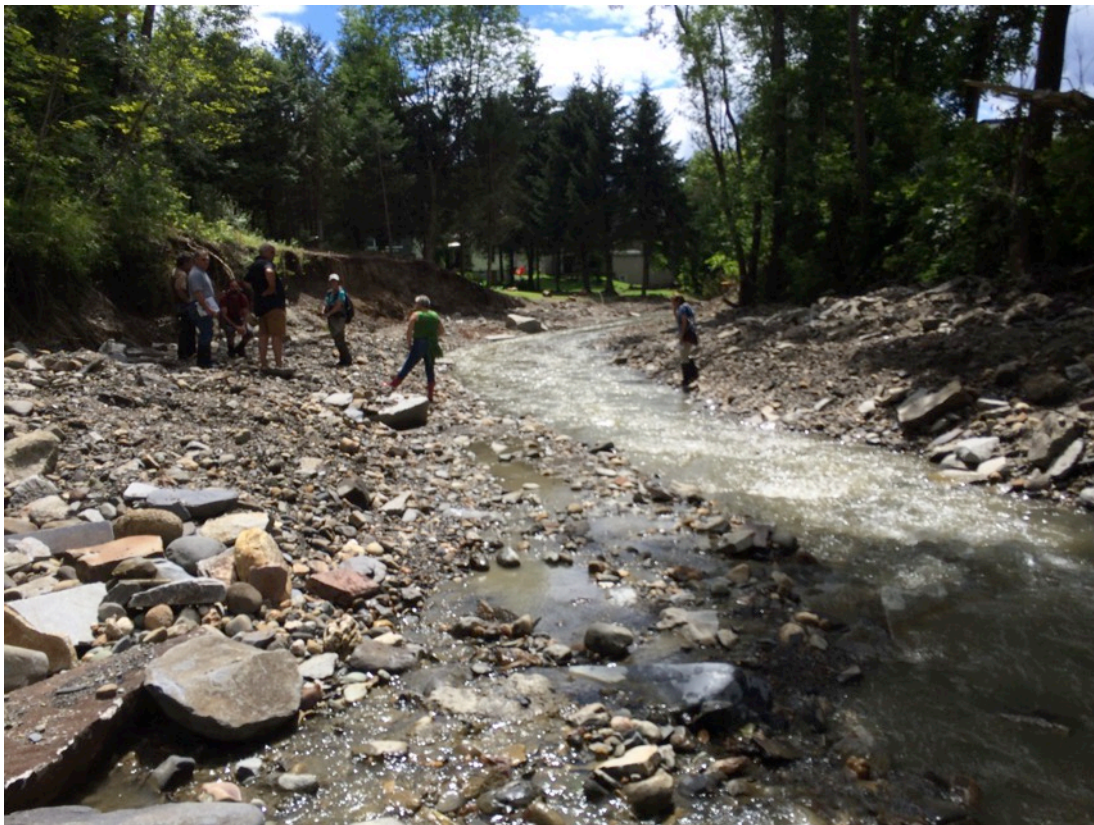
Left bank failed during July 2015 storm

There are several areas in the brook where head cutting and erosion is occurring. For example, much of the bed armor was removed following the July 2015 flood and stabilization with grade control or new bed armor of these areas may be warranted depending on how the brook responds and adjusts. There are opportunities for the use of local, low cost materials to provide stabilization. For example, large woody debris (logs) could be embedded in the channel where the stream bank eroded and channel bed material was removed. As a point of reference, there is a man-made

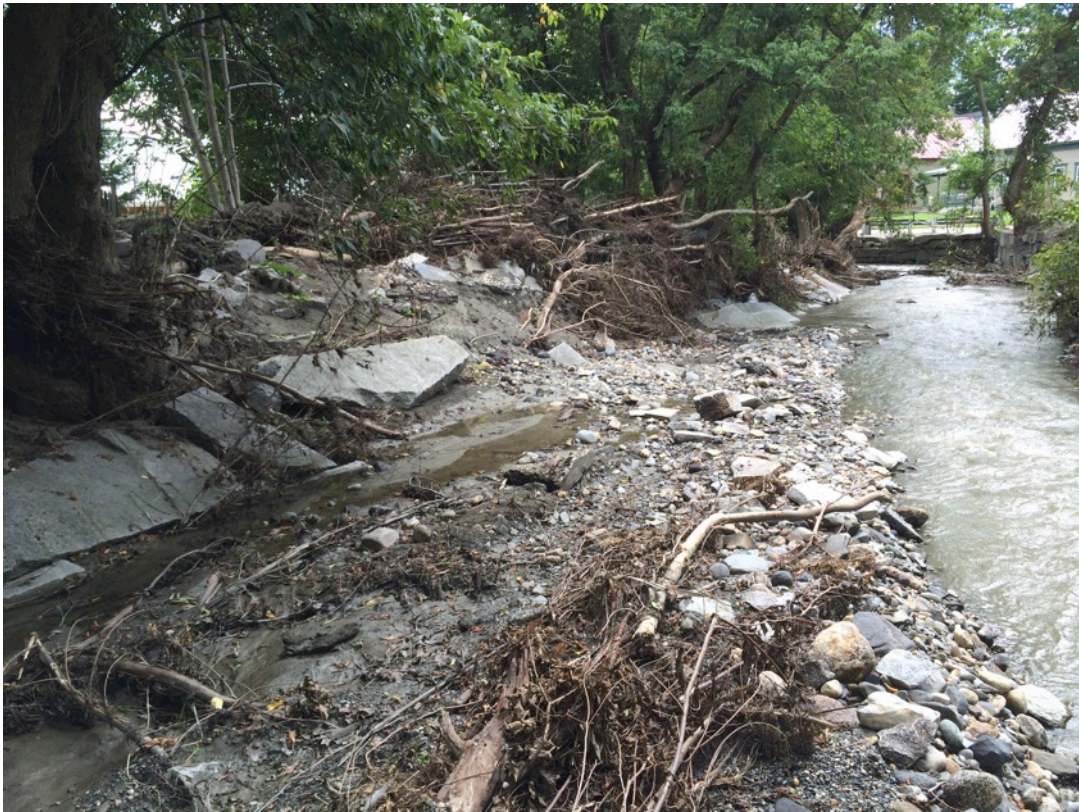
Bank restoration area just upstream of Harrington Ave.

Following building removal, the next step is to restore approximately 300 feet of the left floodplain upstream of Harrington Ave. and about 100 feet downstream. The design intent is to remove historical fill to the maximum practical extent, create a storage area for the woody debris and silts / sediments to collect and settle, to provide access for its removal, to create a more flood resilient channel bank and improve channel dimensions through this area. The primary components to restore the floodplain include:

- Modify (lower) the left bank of the brook to allow floodwater and woody debris to readily access the floodplain. The intent is to widen the channel to a bankfull width and establish a flood resiliency bank condition,

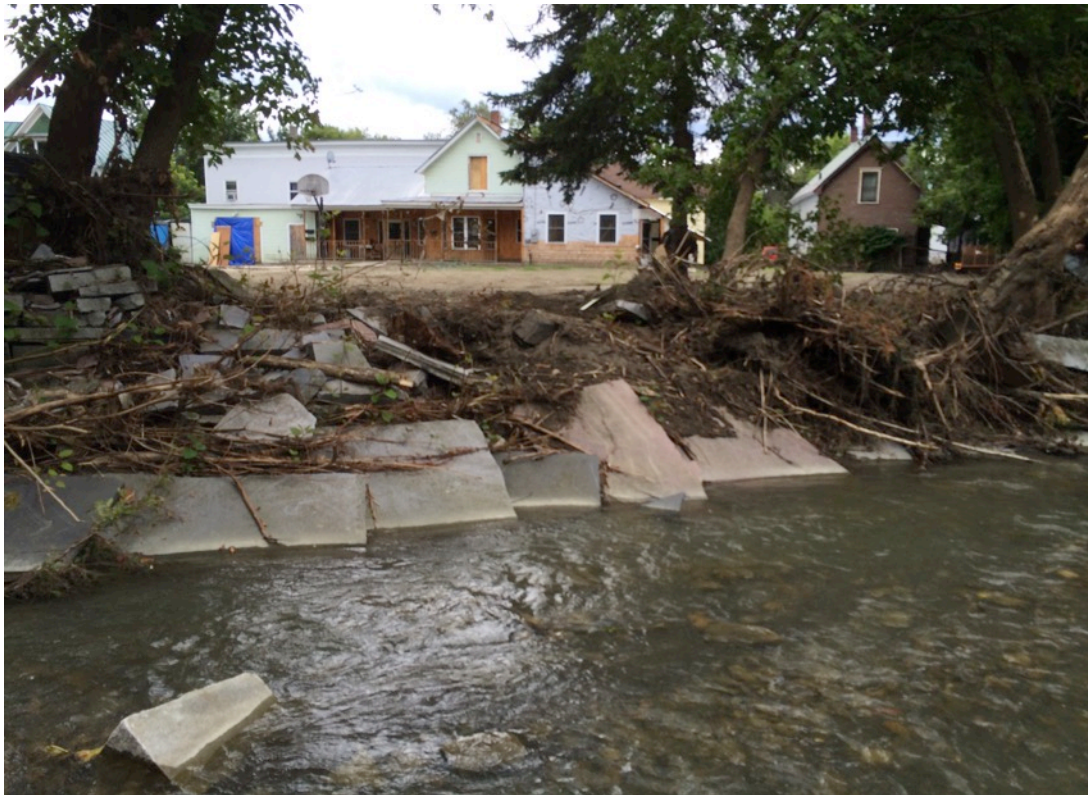
Left floodplain restoration area

- Create a restored floodplain on the east side of the channel to serve as a catchment area for woody debris to settle and for the deposition of excess sediment during a flood event.

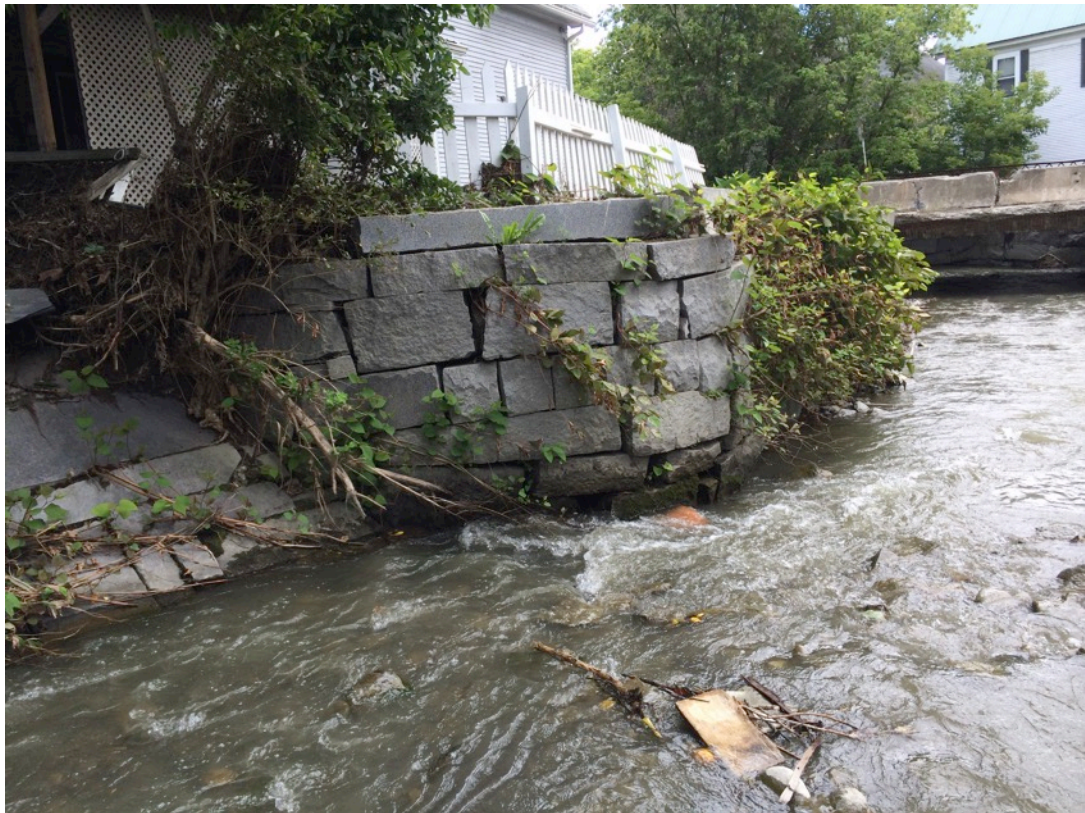
Severe channel constriction at Harrington Ave. bridge

The existing Harrington Avenue bridge deck effectively serves as a woody debris rack, as evidenced by the multiple times debris jams at this site. However, it is an uncontrolled situation because much of the debris remains in the channel, sending floodwaters into the floodplain. Additionally, there is limited direct access to the

- Excavate the accumulated silt and sediment in the area and regrade the land,
- Remove the Harrington Ave. bridge deck, the left abutment and approximately 150 feet of channel improvements downstream of Harrington Ave. Widen the channel in the immediate vicinity of the bridge from its constricted 19-ft to approximately 27-ft. Install a stepped left channel wall.

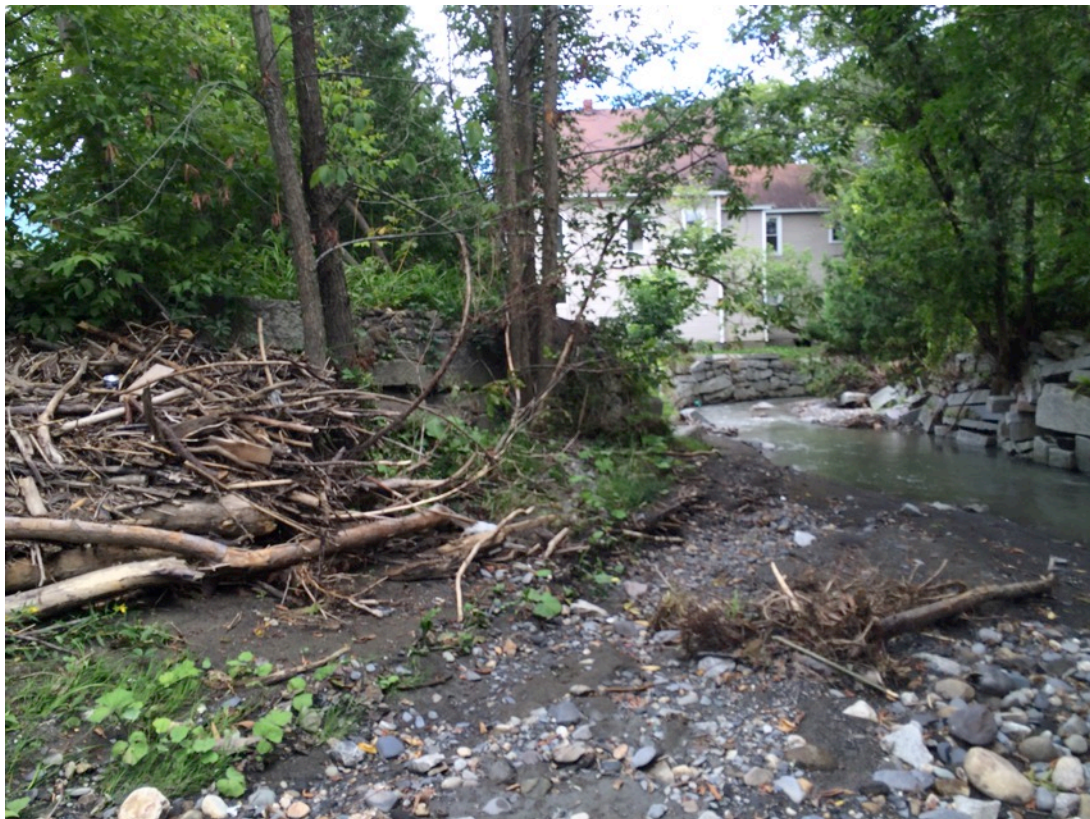
Channel just downstream of Harrington Ave. to be restored

- The left bridge abutment and downstream wall will be lowered as would a short section of wall on the inside (right) bend of the brook just downstream. The intent is to remove some of the historical encroachment fill by lowering the existing walls and creating a wider channel to better match bankfull conditions.

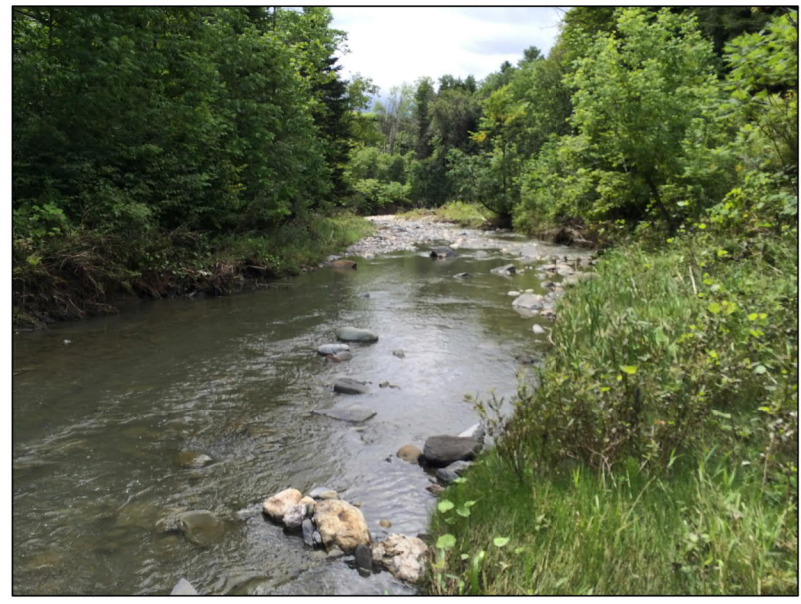
LOCATION FOR LARGE WOODY DEBRIS RACK ADJACENT TO LEPAGE GRAVEL PIT

- City access (with Owner's permission) to the trash rack and debris storage area would be provided off Farwell St and through the LePage Gravel Pit road system. Permanent easements to construct and maintain the debris rack would be required from all property owners affected by the trash rack.
- A structural steel H-pile, driven into the streambed along with welded cross bars and bracing would serve as the frame for the trash rack.
- Initial coordination with officials from the VANR Rivers Management Program has occurred and verbal, preliminary concurrence to construct and maintain a trash rack has been received. Formal authorization from VANR and the Army Corps of Engineers through the permit process will be required as part of final design.

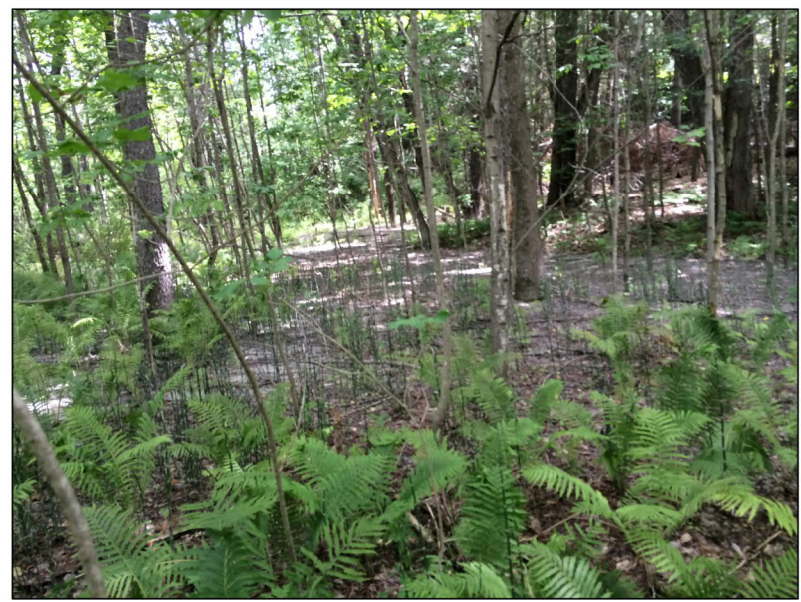
WOODED FLOODPLAIN TO SERVE AS BYPASS FLOW AREA

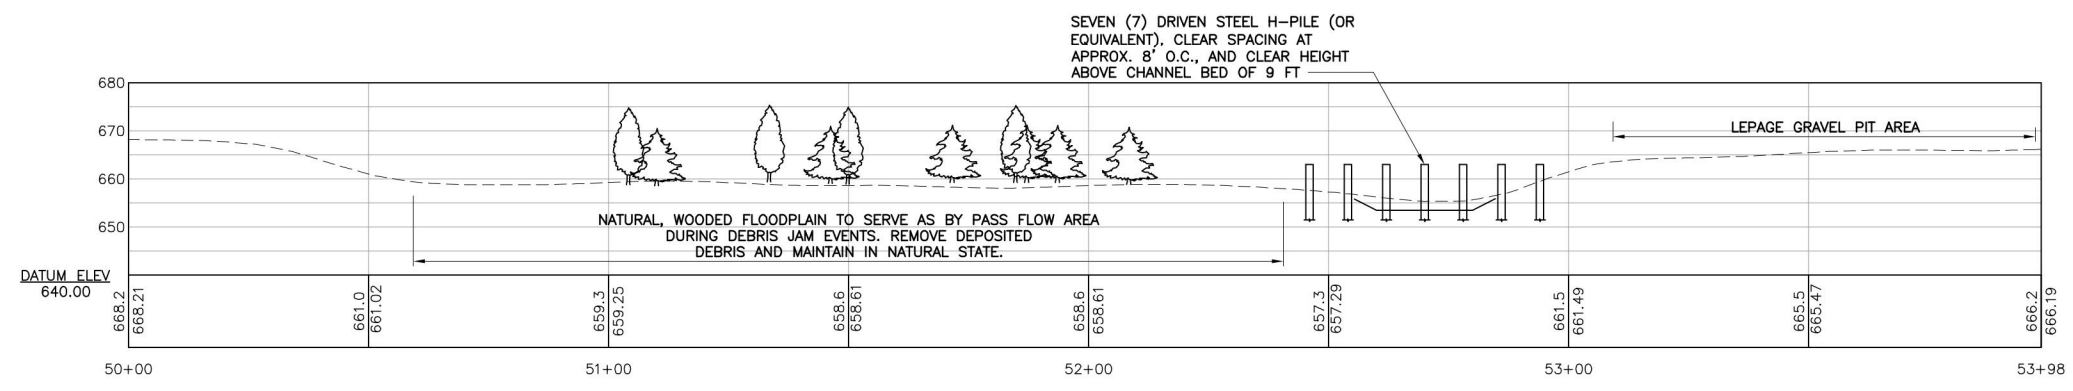
LARGE WOODY DEBRIS RACK ELEVATION (LOOKING DOWNSTREAM)

- Catch and retain the majority of woody debris migrating down Gunners Brook from further upstream and reduce the potential for this debris to enter into the urban floodplain of Gunners Brook.

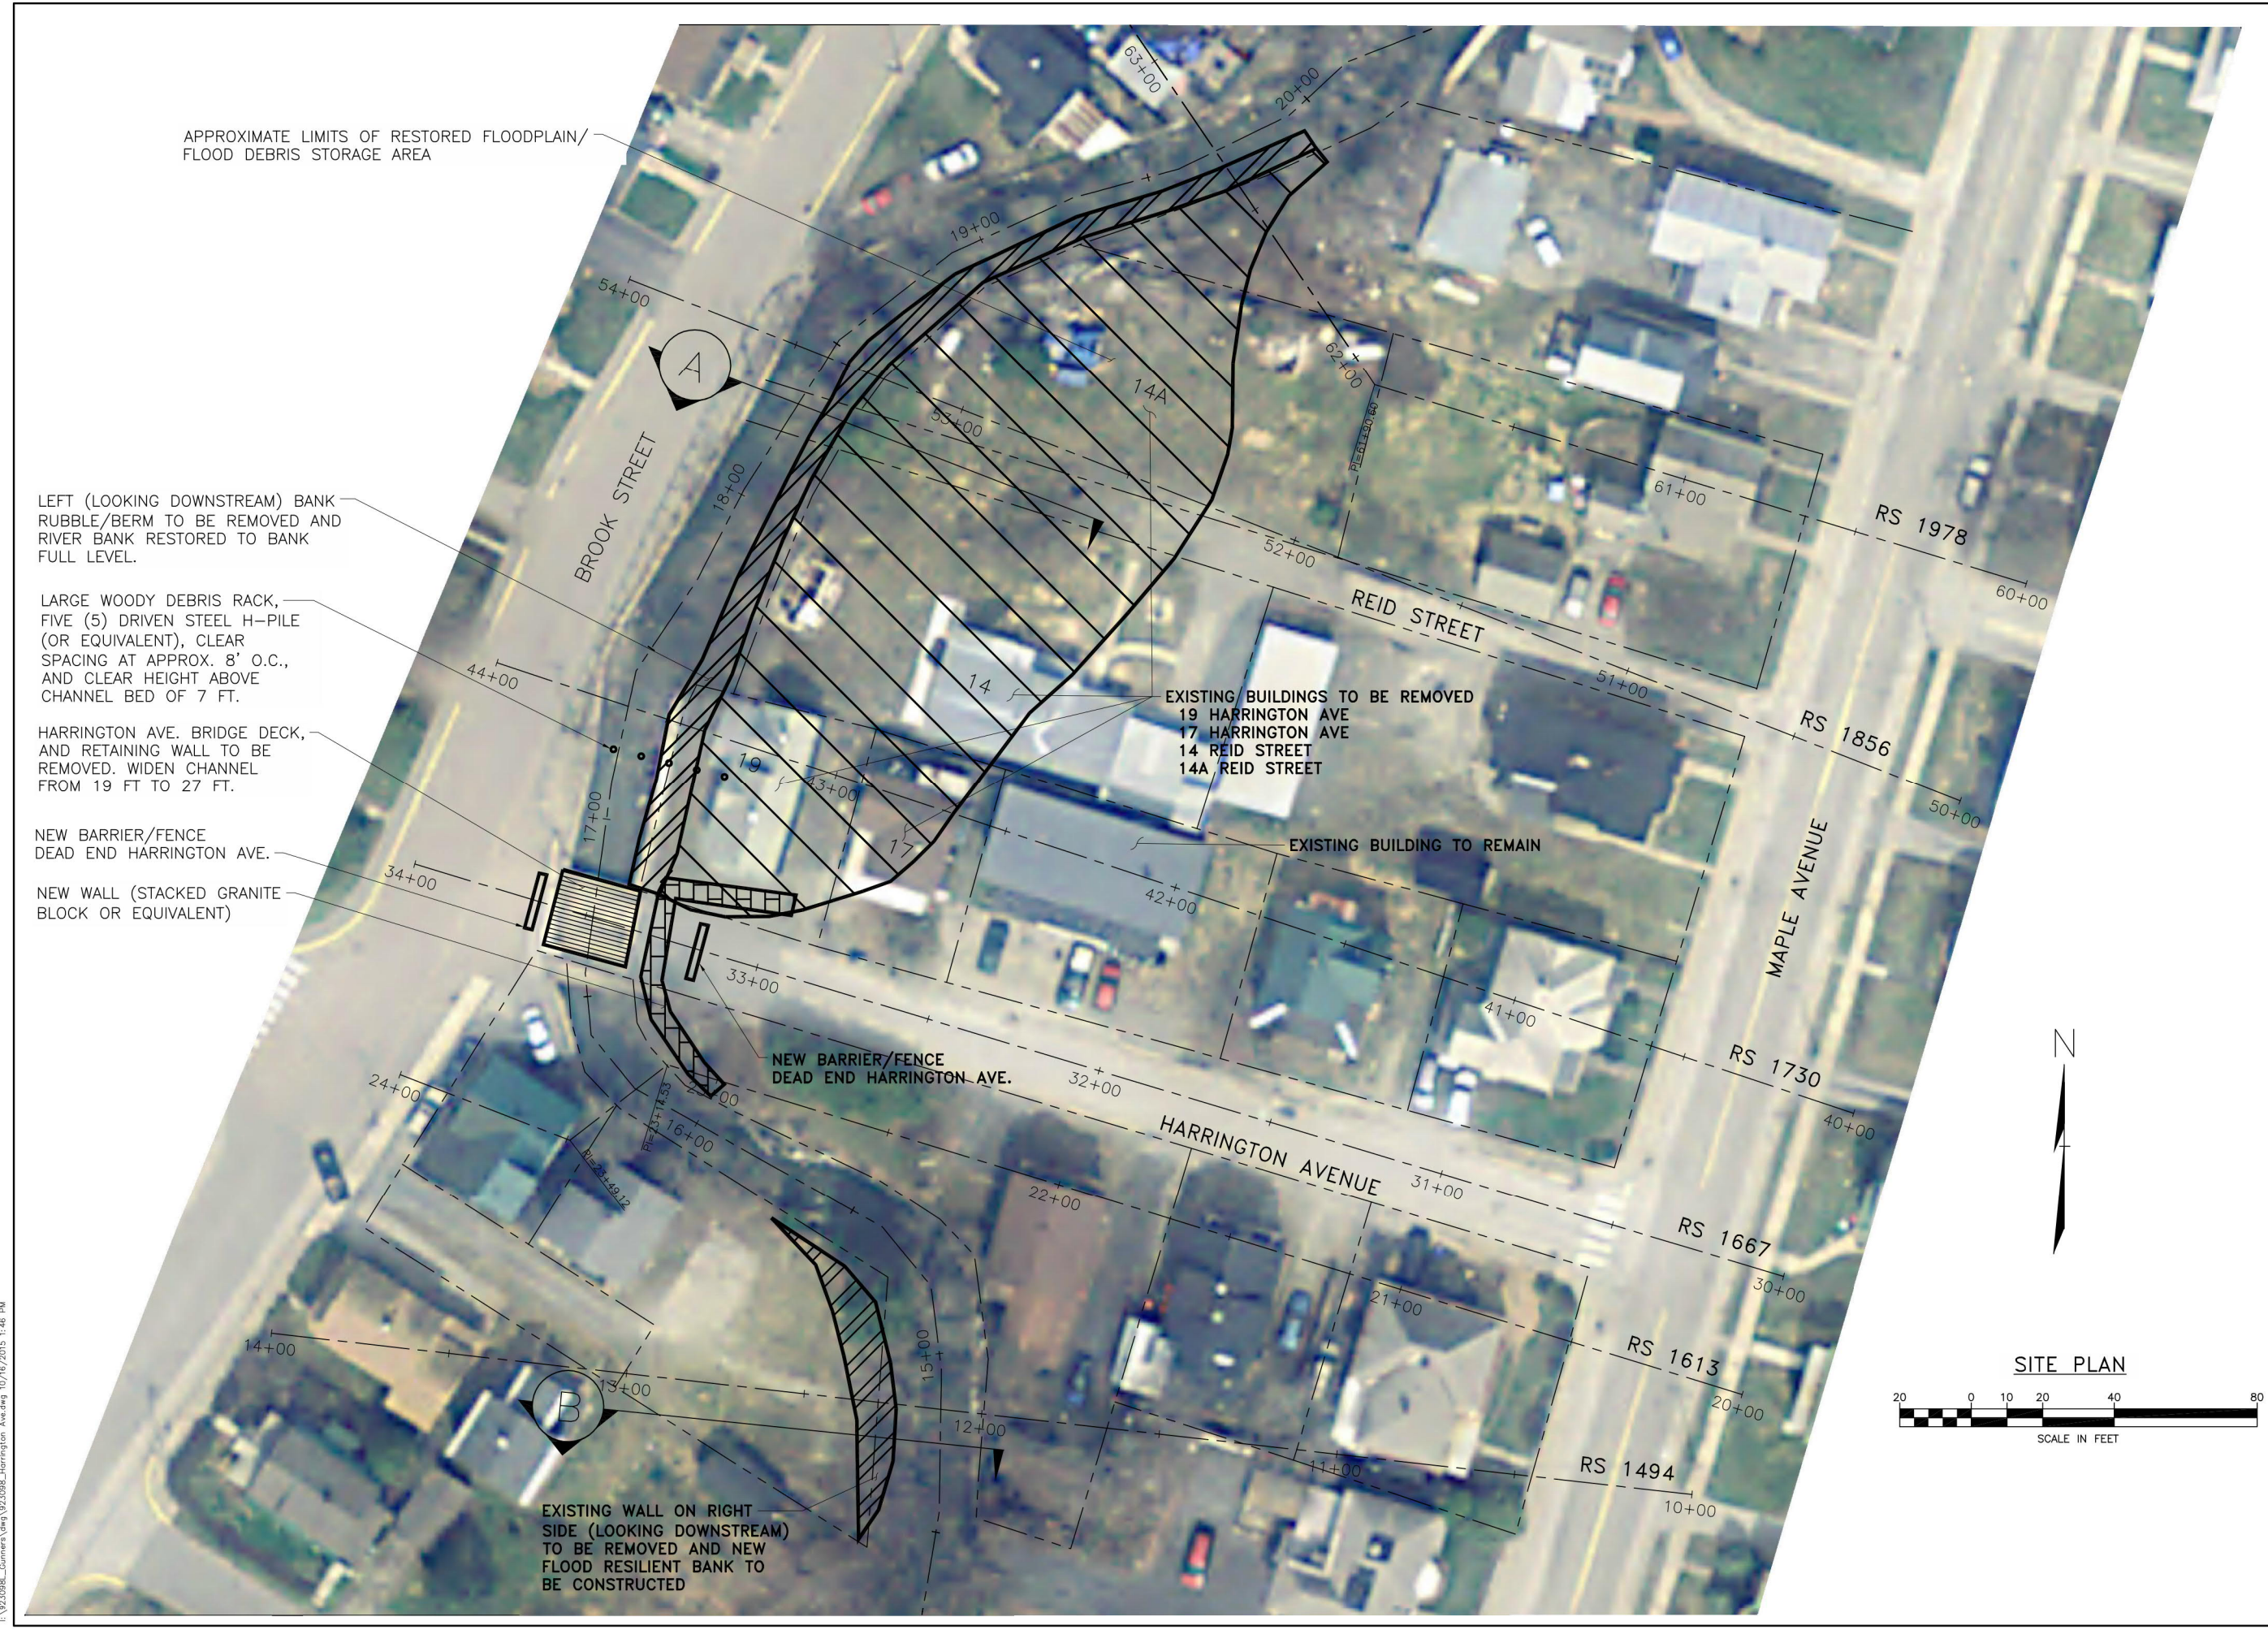
HARRINGTON
SITE PLAN

APPROXIMATE LIMITS OF RESTORED FLOODPLAIN/
FLOOD DEBRIS STORAGE AREA

LEFT (LOOKING DOWNSTREAM) BANK
RUBBLE/BERM TO BE REMOVED AND
RIVER BANK RESTORED TO BANK
FULL LEVEL.

LARGE WOODY DEBRIS RACK,
FIVE (5) DRIVEN STEEL H-PILE
(OR EQUIVALENT), CLEAR
SPACING AT APPROX. 8' O.C.,
AND CLEAR HEIGHT ABOVE
CHANNEL BED OF 7 FT.

HARRINGTON AVE. BRIDGE DECK,
AND RETAINING WALL TO BE
REMOVED. WIDEN CHANNEL
FROM 19 FT TO 27 FT.

NEW WALL (STACKED GRANITE
BLOCK OR EQUIVALENT)

EXISTING BUILDINGS TO BE REMOVED
19 HARRINGTON AVE
17 HARRINGTON AVE
14 REID STREET
14A REID STREET

Woody Debris Trash Rack at Harrington Avenue:

- Unlike the LePage site, a different styled trash rack is recommended, one that would be suitable for a residential area. There are a number of material and shape configurations that would be evaluated during the next phase of this project. The individual piers of the trash rack would be located in both the channel of the brook as well as the floodplain upstream of Harrington Ave.

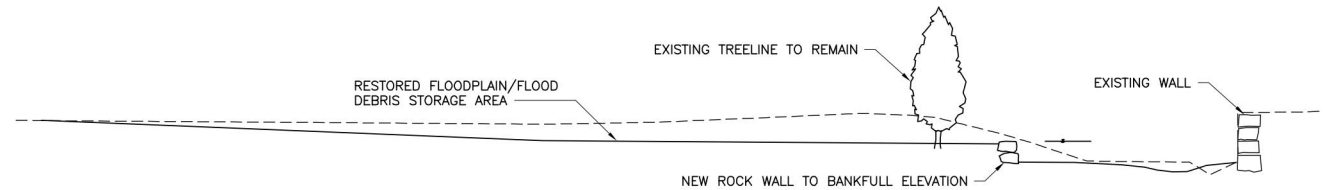
A TYPICAL SECTION

HARRINGTON
CROSS SECTIONS
